Arboricultural Assessment & Report  
*Corymbia ficifolia* (Flowering Gum)  
Wimmera Hwy, Apsley Victoria

## Arboricultural Assessment Report

Wimmera Highway, Apsley

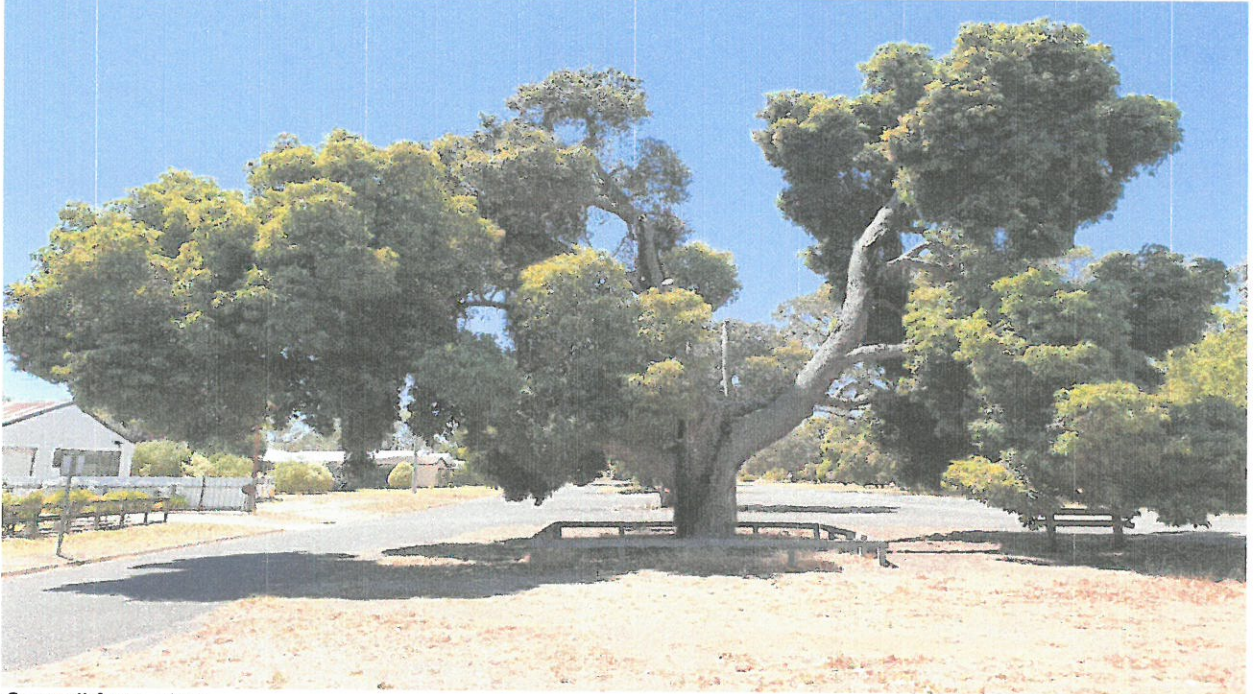
(Front View) Picture 01

Overall front view.

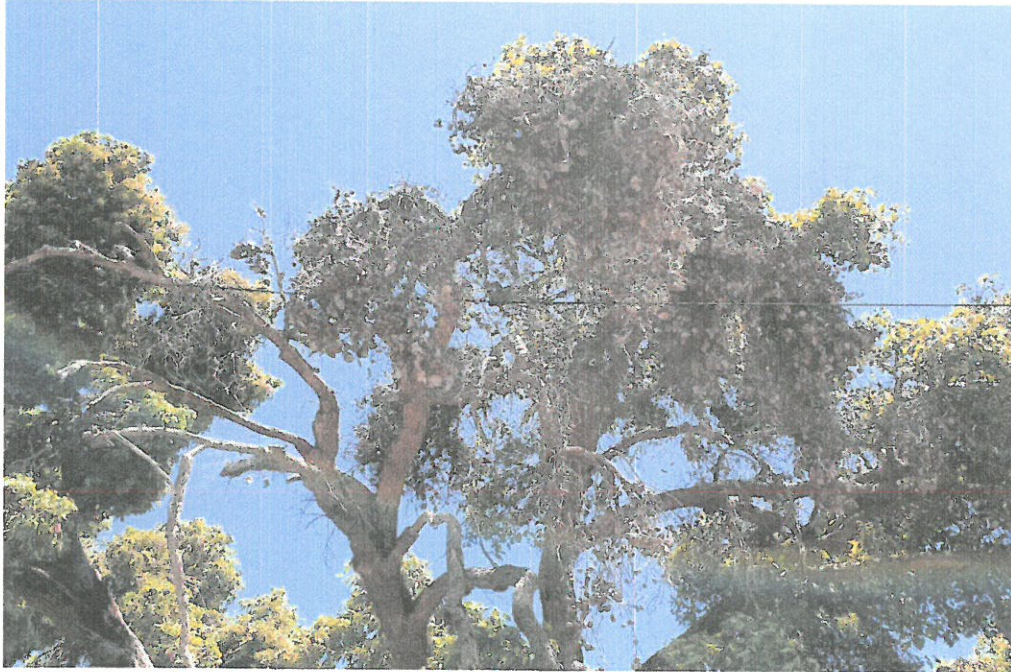
(Rear View) Picture 02

Large amounts of dead wood, which is also resting on the mains wire.

- a) The *Corymbia ficifolia* (flowering gum) is recommend for a wide range of pruning methods as below.
- b) Pruning and weight reductions of large heavy outer limbs to reduce the possibility of limb failure.
- c) Removal of deadwood for public safety as this tree is a town icon and has public within close proximity.
- d) Removal of limb touching and protruding onto the powerlines as this could possibly catch on fire.
- e) Crown reduction for general trees health and wellbeing.
- f) Uplift and reducing outer limbs to remove of limbs intruding onto the road.

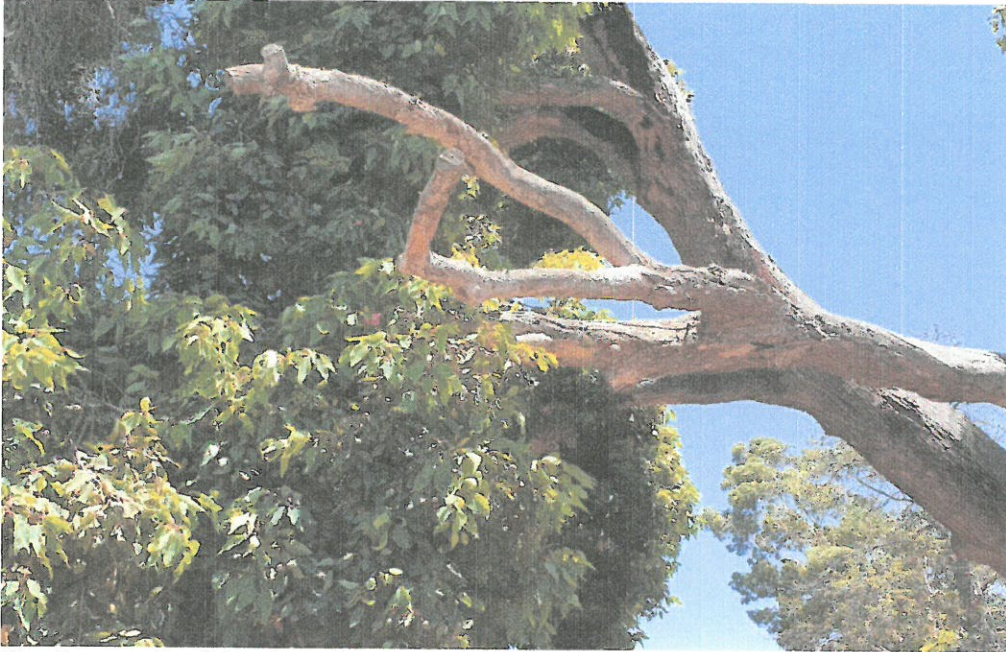
*(Front View) Picture 03*

*Small amounts of deadwood.*

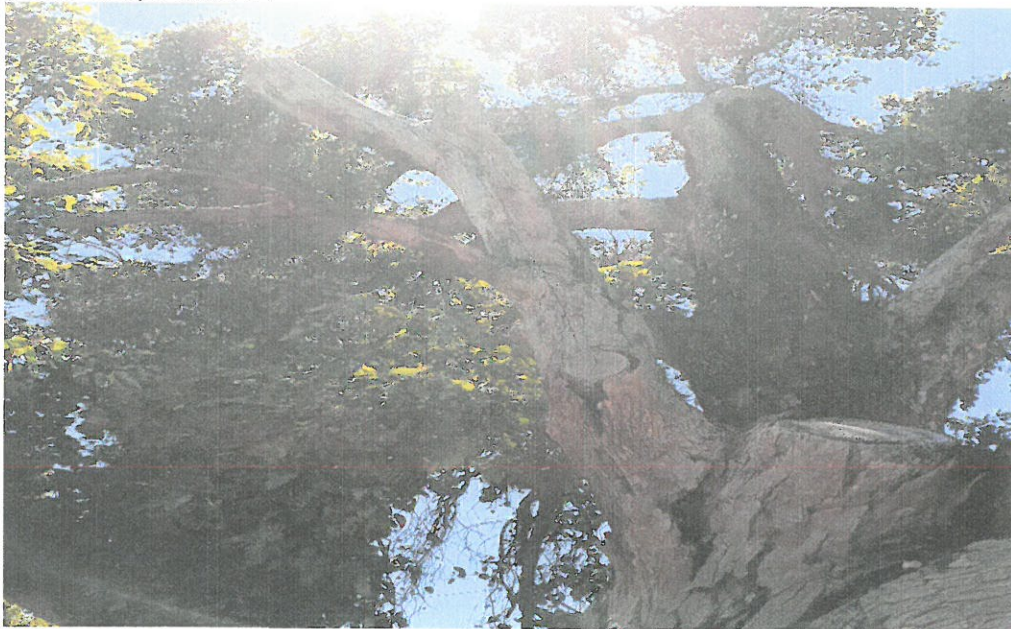
*(Front View) Picture 04*

*Large dead limb*

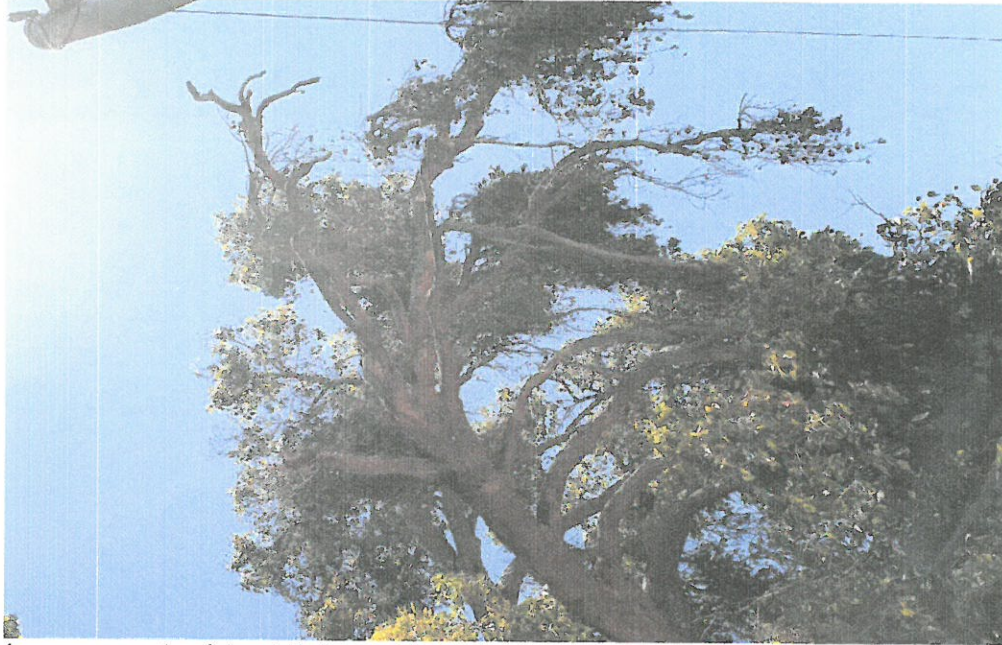
*(Rear View) Picture 05*

*Large amounts of dead limbs and branches.*

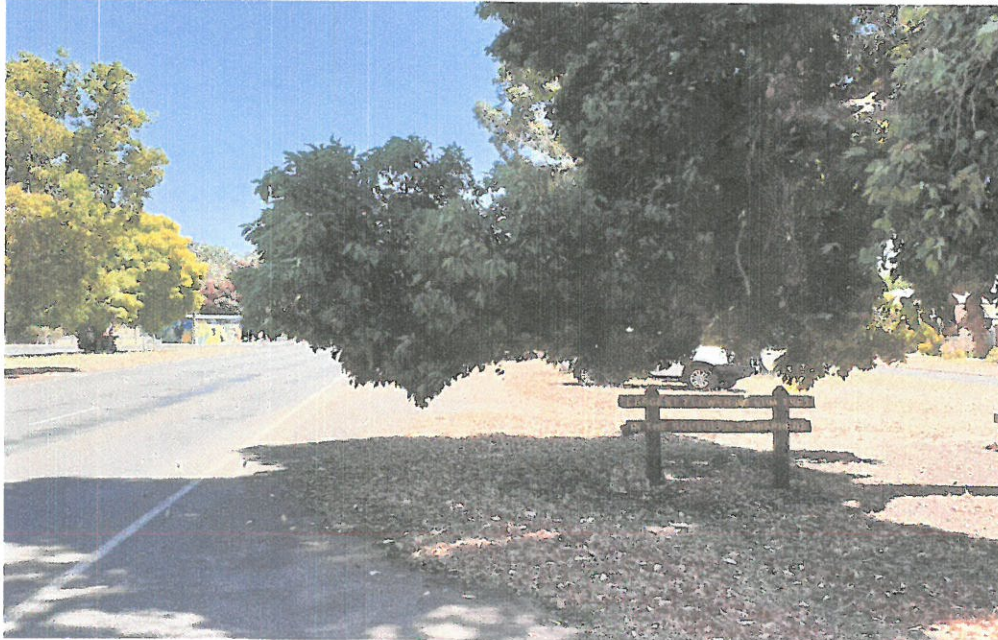
*(Rear View) Picture 06*

*Large limb intruding onto the Wimmera Hwy.*

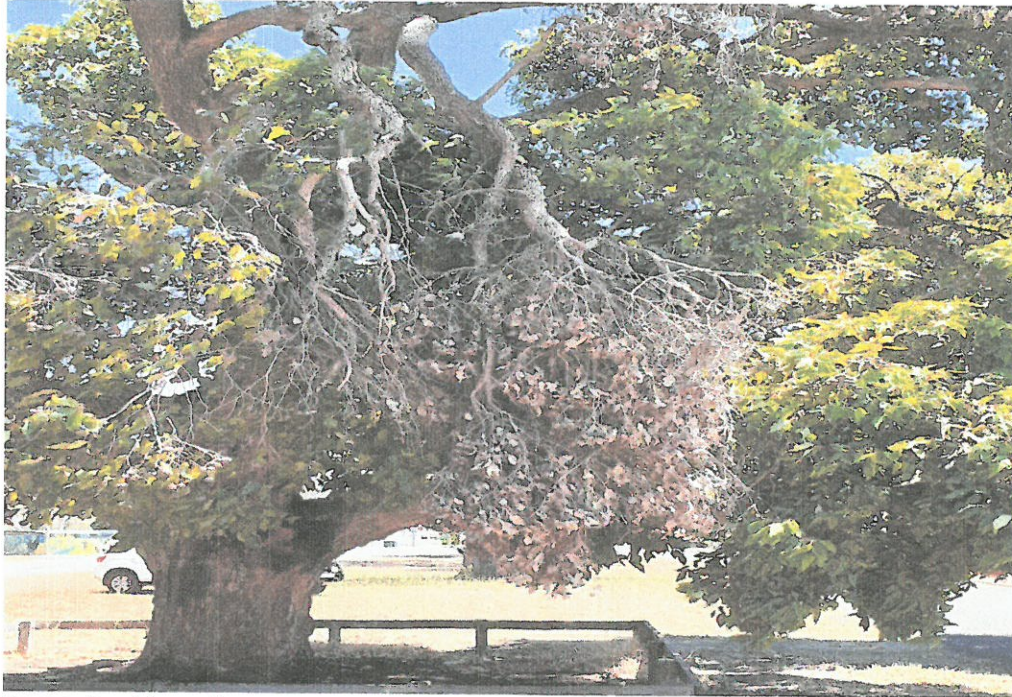
*(Rear View) Picture 07*

*Large dead branch.*

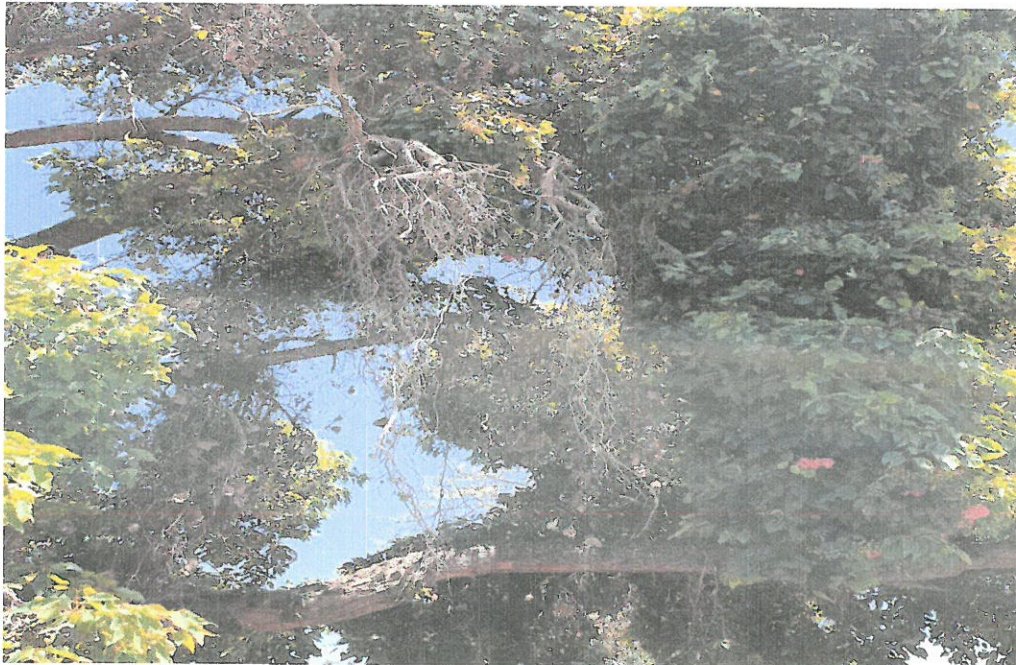
*(Rear View) Picture 08*

*Small amounts of dead branches.*

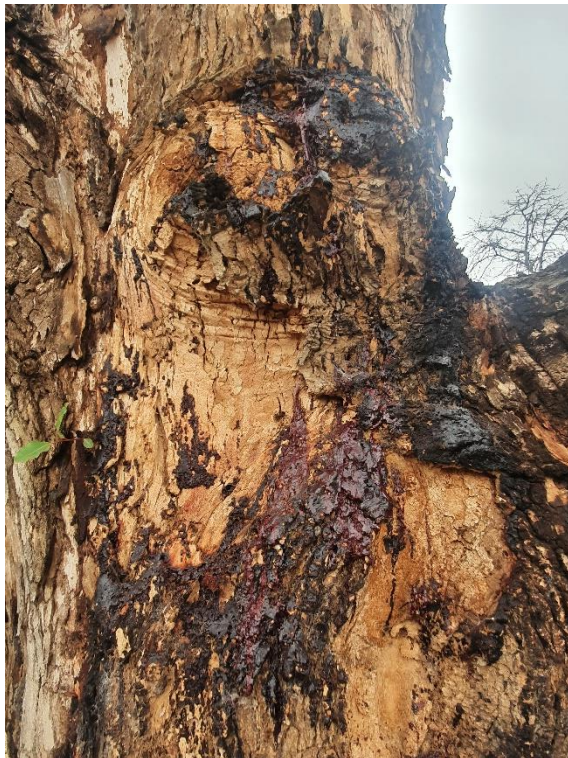
Image 1: Exudates on main trunk of subject tree

Previous pruning has been poor and is the likely source of the dysfunctional tissue in the main stem which has allowed insect damage and possibly infection with fungal pathogens.

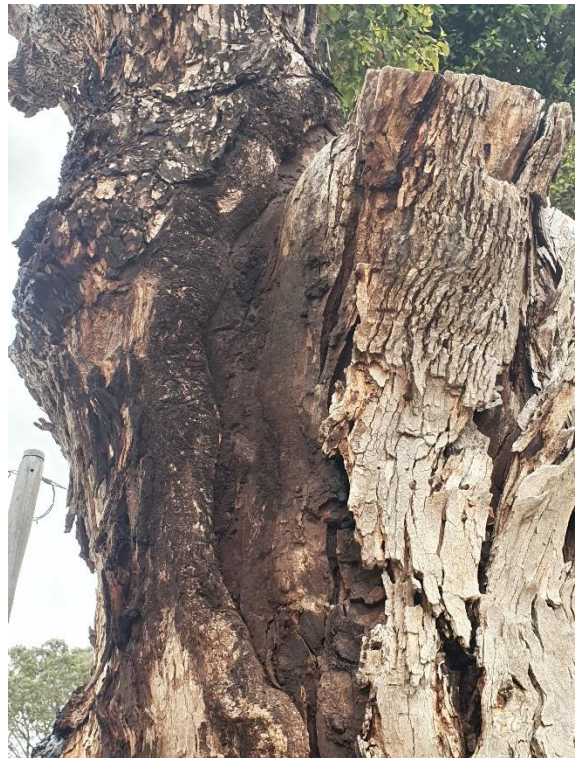
Image 2: Signs of insect activity in areas of dysfunction on the main trunk of subject tree

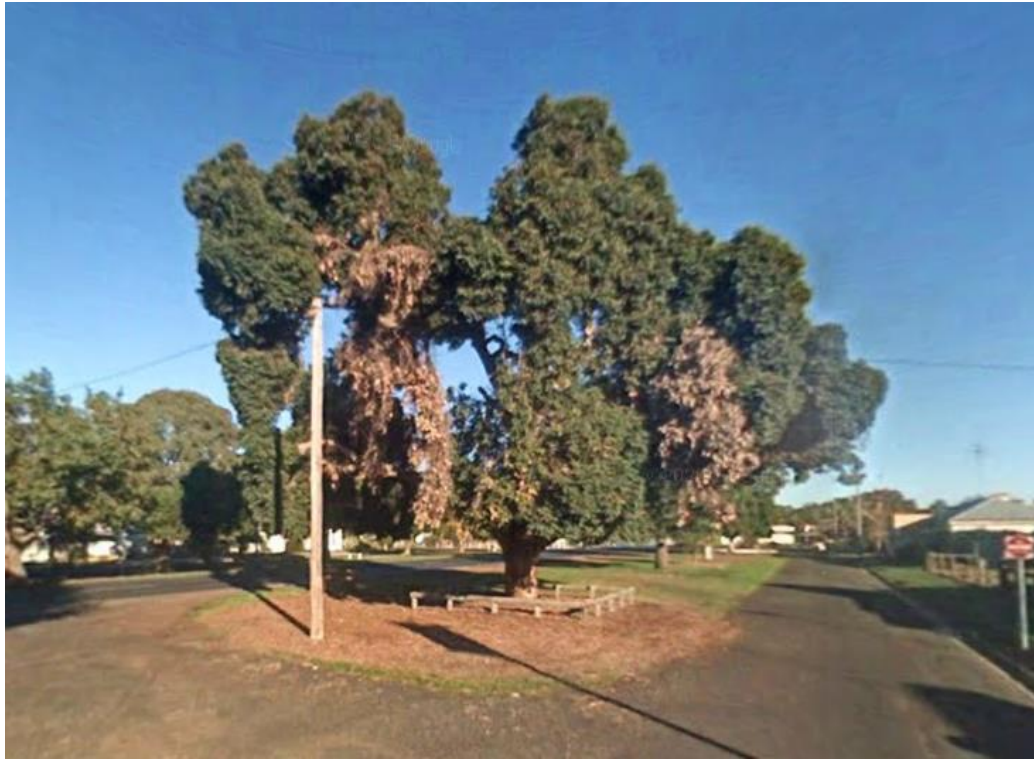
**Image 3: Street view of tree May 2008**

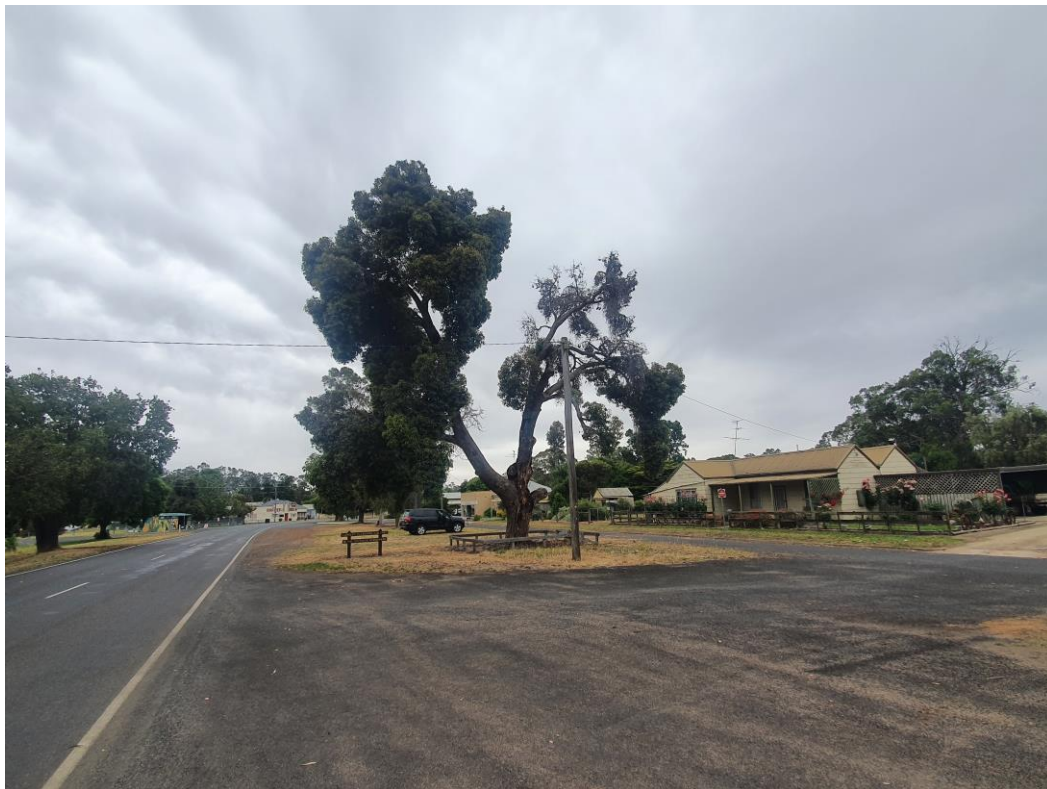
**Image 4: Subject tree 2020**

A recent failure has resulted in a significant portion of the northern side of the canopy being removed from the tree

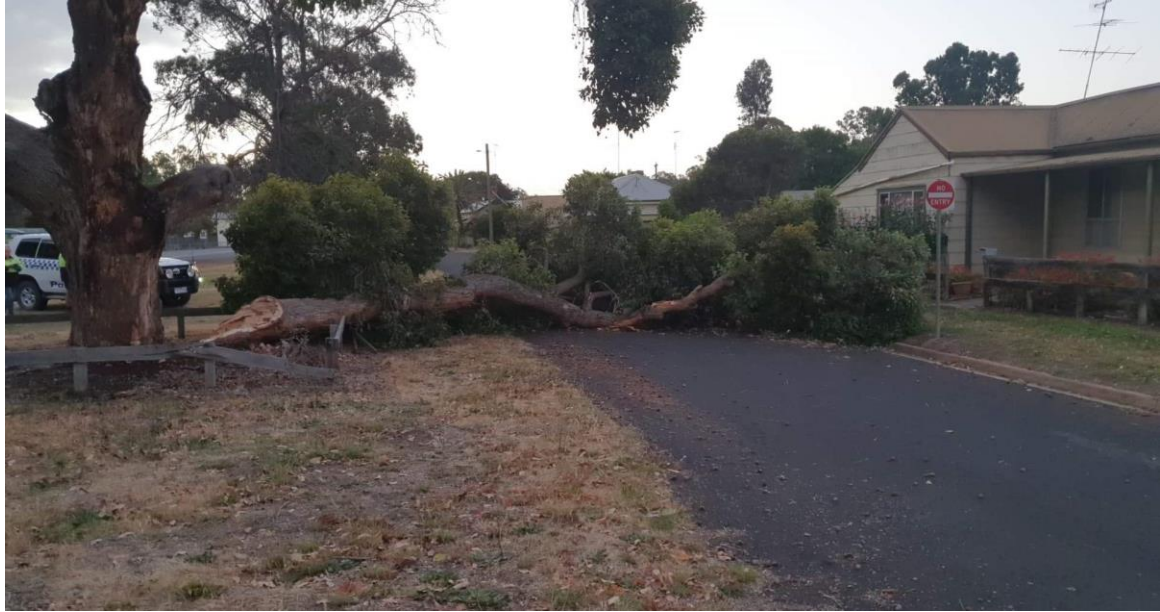
**Image 5: Failed limb**

The subject tree has seen significant failure of a large structural limb resulting in modification of crown distribution and loss of amenity.

It is recommended that the tree is removed and a replacement specimen planted
