West Wimmera Shire Council

Lake Wallace

Lake Management Observations

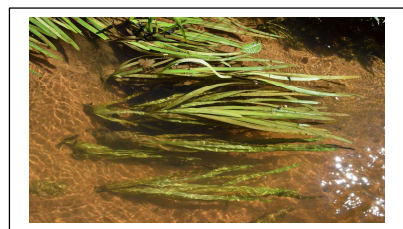
Triglochin procerum commonly known as *Water Ribbons*, is the significant aquatic vegetation habitat noted in the 2016 Growling Grass Frog report. Triglochin is an Australian native emergent aquatic plant, with tuberous roots, with some leaves floating and others erect between 0.5 to 2 metres in length, with dense seed spikes to 30cm in length. Seeds germinate readily in autumn. In temperate areas growth as well as flowering takes place in spring and summer with fruiting in late summer or autumn. As the Triglochin is easily differentiated from the other two types of aquatic vegetation in the lake, to maintain Growling Grass Frog habitat cutting Triglochin can easily be avoided when harvesting. For a detailed assessment of potential impacts on the Growling Grass Frog and their habitat from any lake vegetation management activities a herpetologist should be consulted for an opinion.

Triglochin

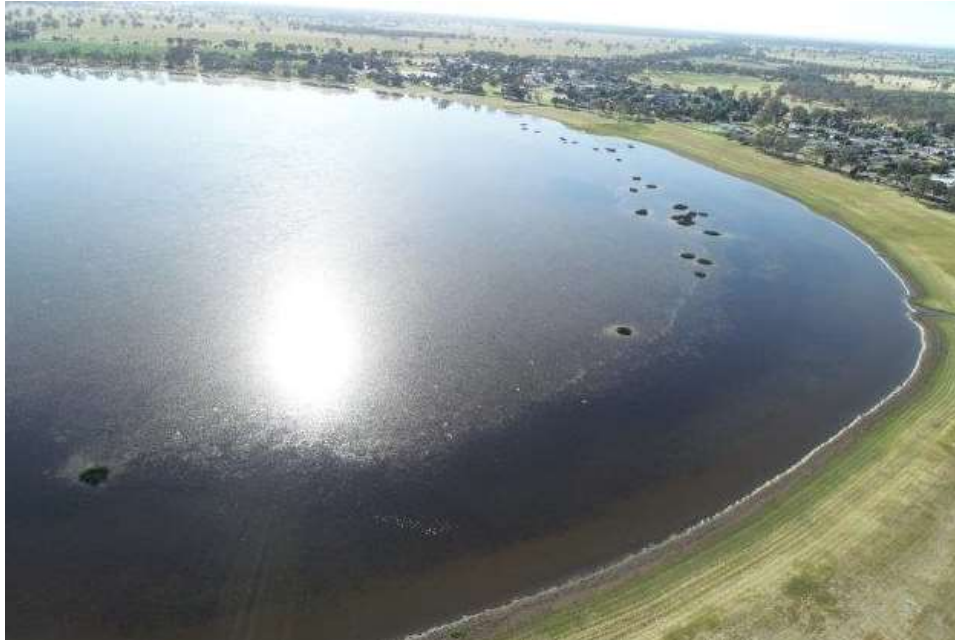
Image taken on or around the 30/11/2021

This image shows the majority of the lake vegetation is dominated by Vallisneria

Aerial drone images show that the vast majority of the lake, apart from a narrow band of clear water immediately on the edges of the lake, is densely covered with aquatic plant growth. It is estimated that 90% of the lakes surface has submerged aquatic vegetation beneath. The images also show that the vegetation coverage is fairly uniform and dense in coverage.

Coverage is considered to change as the lakes water level drops over the summer period.

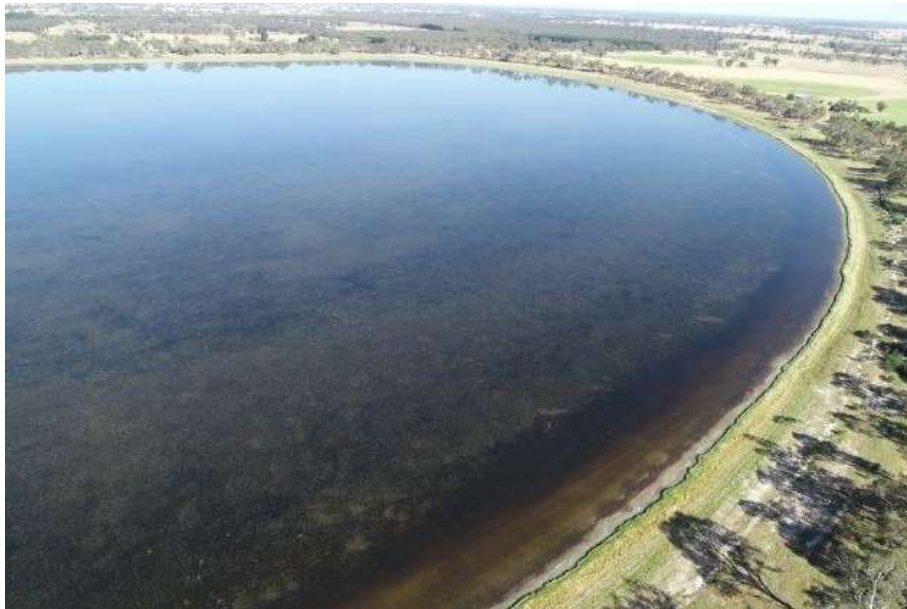
Image taken on or around the 30/11/2021

The Vallisneria as it grows towards the water surface and or the water level drops to meet the Vallisneria it results in a fold over of the leaf. This then fatigues the leaf and causes parts to break off. Also, wind and wave action can whip out larger strands of the aquatic plant. These factors cause a pile of detached aquatic vegetation to gather at the downward wind edge of the lake.

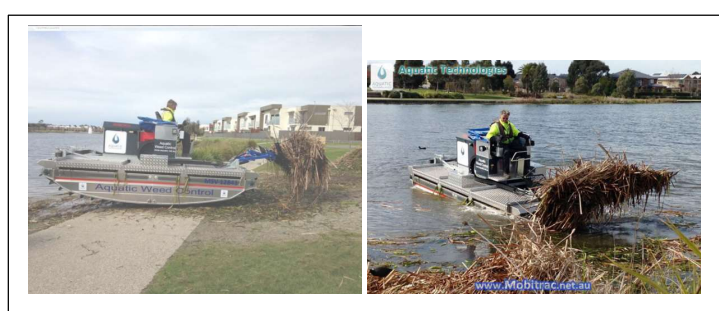
Images of amphibious craft collecting & moving cut vegetation out of the water
