# **Harrow Flood Investigation Draft Final Report**

**June 2017**

| Project Name | Harrow Flood Investigation |
| Client | Glenelg Hopkins CMA |

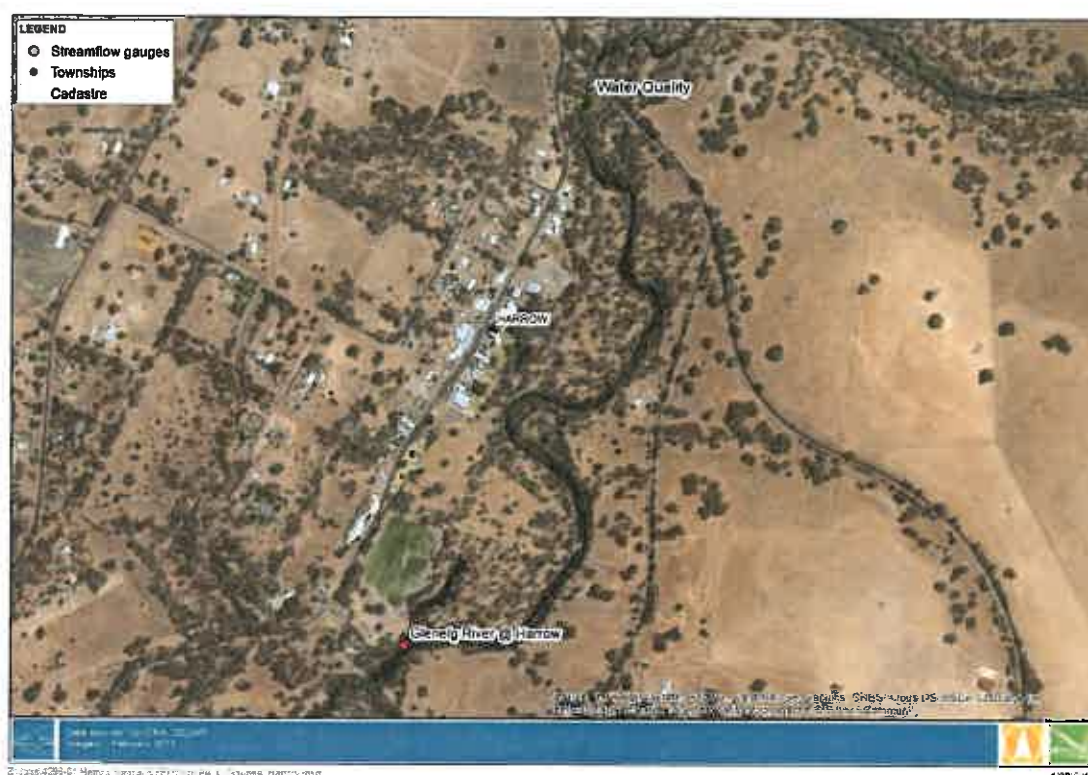
It must be noted the water quality and gauge height measurements for the Harrow gauge are in different locations with the water quality recordings taken approximately 350 m downstream of

**Figure 3-4 Harrow streamflow and water quality gauge locations**

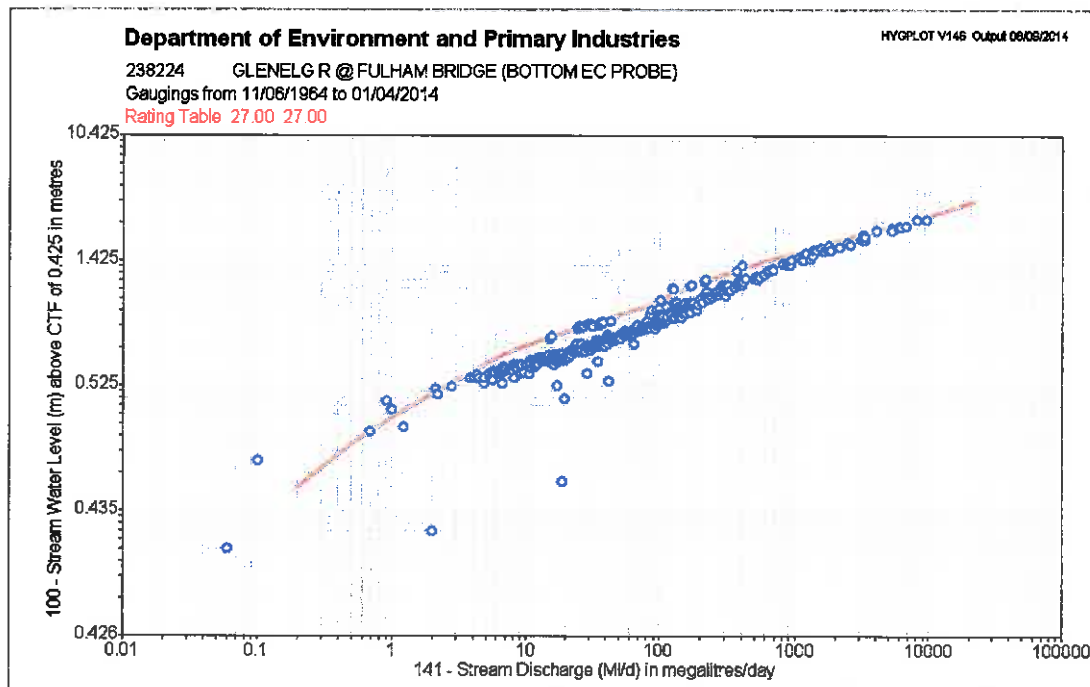
Figure 3-5 Comparison of the measured water levels and flows at Fulham Bridge<sup>2</sup>

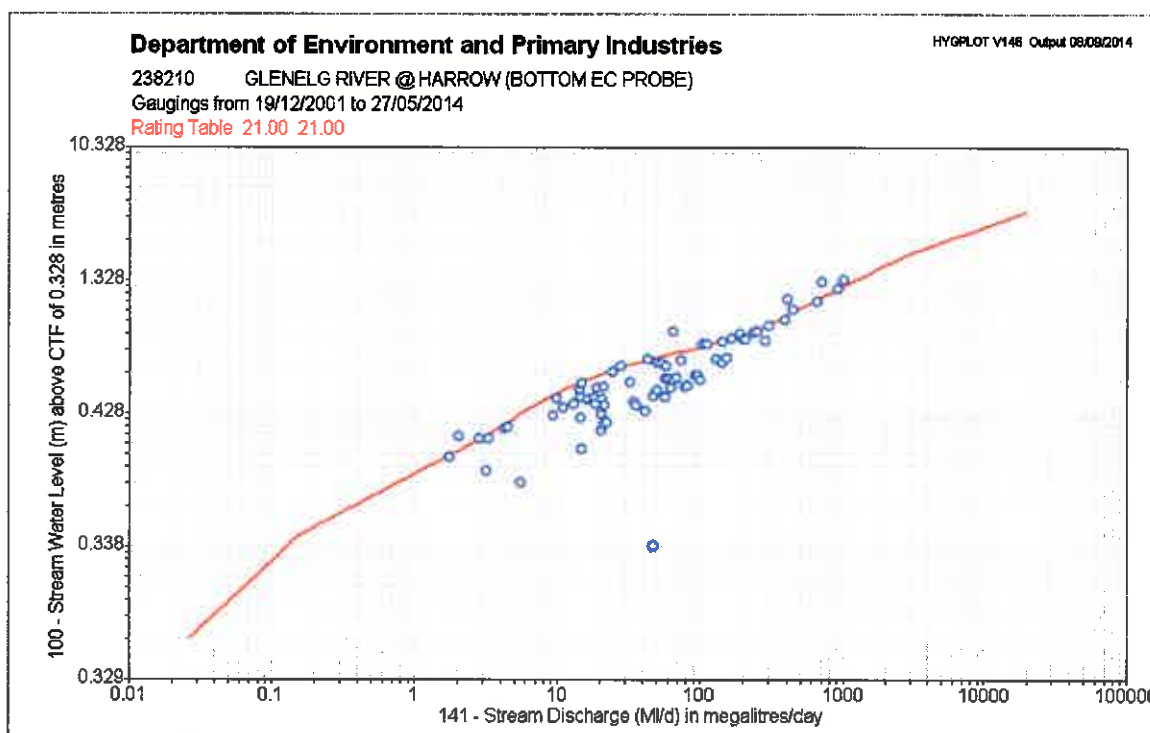
The Harrow gauge rating is not as accurate and doesn't cover the same flow range as the Fulham Bridge gauge. The gauge is only considered reliable over a very narrow range, between 0.54 m and 1.1 m, or 0.3 m<sup>3</sup>/s and 8.8 m<sup>3</sup>/s (28 ML/d and 760 ML/d). Despite the rating curve not being considered reliable for flows above 8.8 m<sup>3</sup>/s (760 ML/d), the Glenelg River Regional Flood Mapping Project<sup>1</sup> showed that the extrapolated rating curve and observed flows matched the modelled flows very closely when routing Fulham Bridge observed flows and RORB modelled tributary inflows through a 1D model of the Glenelg River. This suggests the extrapolated rating curve is reasonably good for flows up to the calibrated December 2010 flow of nearly 54.4 m<sup>3</sup>/s (4,700 ML/d).

**Figure 3-7 Comparison of the measured water levels and flows at Harrow<sup>2</sup>**

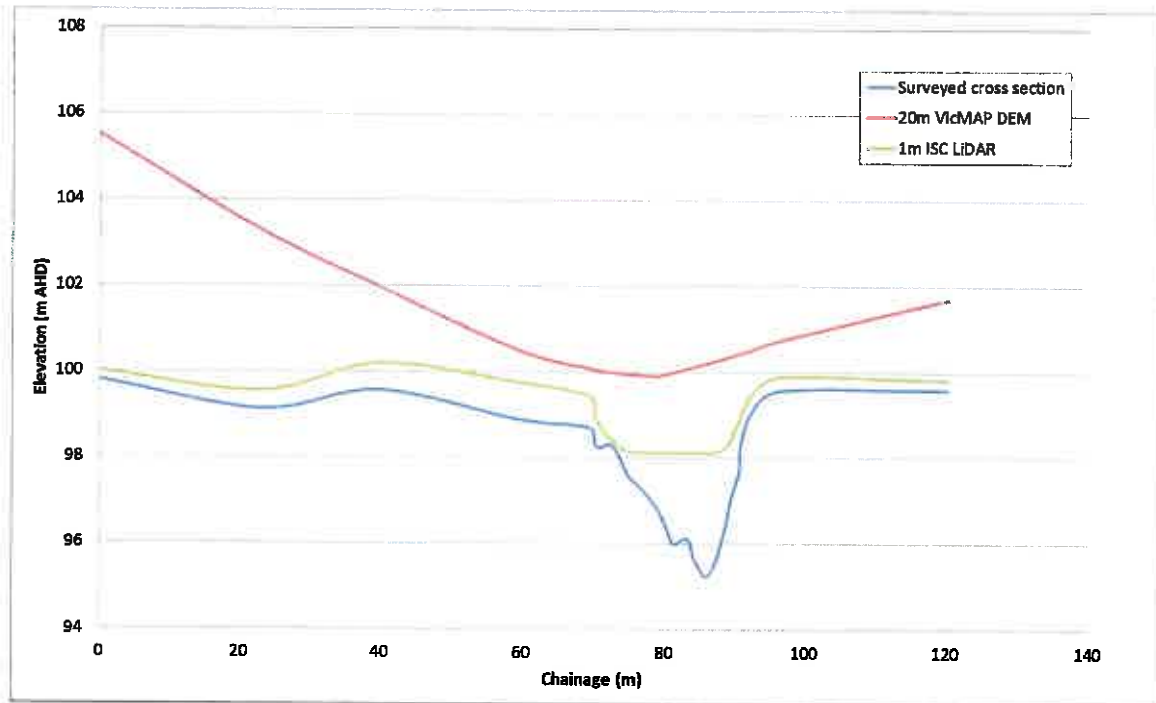
The surveyed transects showed a clear difference between the LiDAR and the surveyed transects, with the ISC LiDAR consistently higher than the survey. This was observed for survey data locations along the Glenelg River across all survey sources. The LiDAR verification process identified the difference between the survey and LiDAR data to be 0.32 m (ISC - Survey), meaning the ISC LiDAR data was 0.32 m higher than the survey. This was verified by the LiDAR verification undertaken during the Casterton Flood Investigation<sup>13</sup> and Skipton Flood Investigation<sup>14</sup>, which also found a uniform difference between the ISC LiDAR data and survey heights of 0.32 m. In both projects the ISC LiDAR data was lowered to accommodate for this difference. This shift in the LiDAR was used for the Harrow Flood Investigation, and no further control transects to verify the LiDAR datasets were required.

As shown in the below figures, the Glenelg River channel was generally not well represented by the LIDAR as it has captured the water surface at the time of survey. The available cross-section survey (shown in Figure 3-15) data was used to stamp in the channel to ensure its capacity was properly represented. Further transects focusing on the Glenelg River road crossings between Rocklands and Casterton are shown in Appendix A.

**Figure 3-13** Survey vs ISC LIDAR data cross section comparison at Harrow, Harrow Rehabilitation Survey – Chainage 1400 m

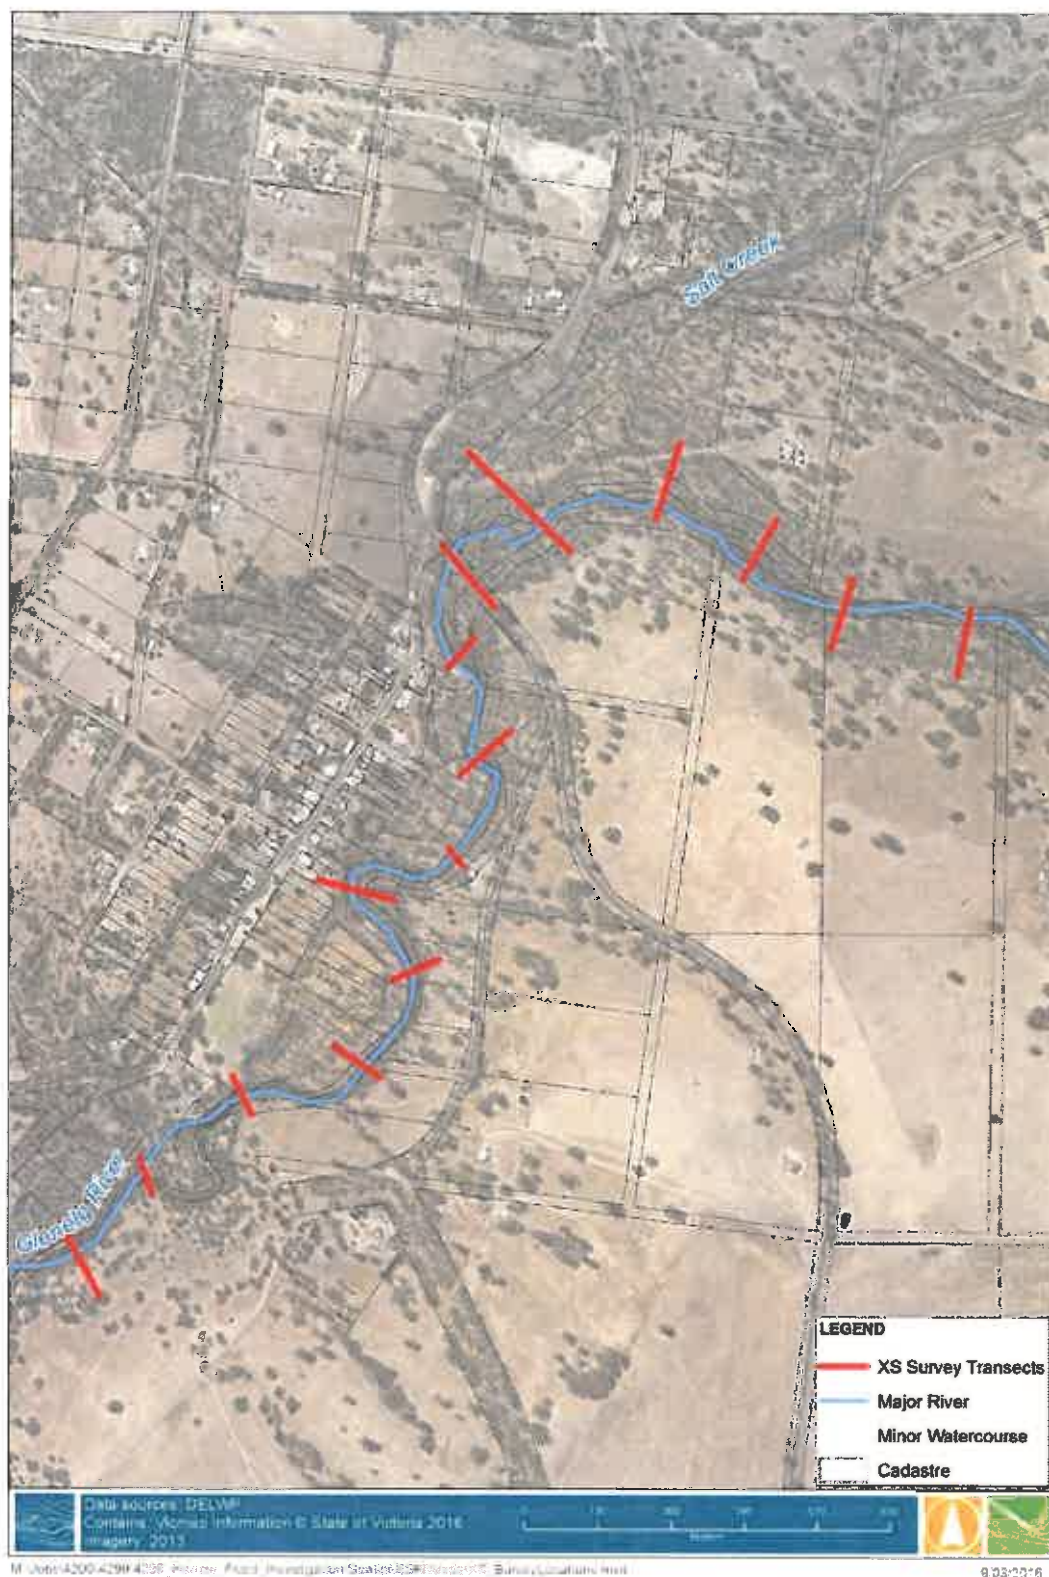
**Figure 3-15 Available cross-section survey transects<sup>10</sup>**

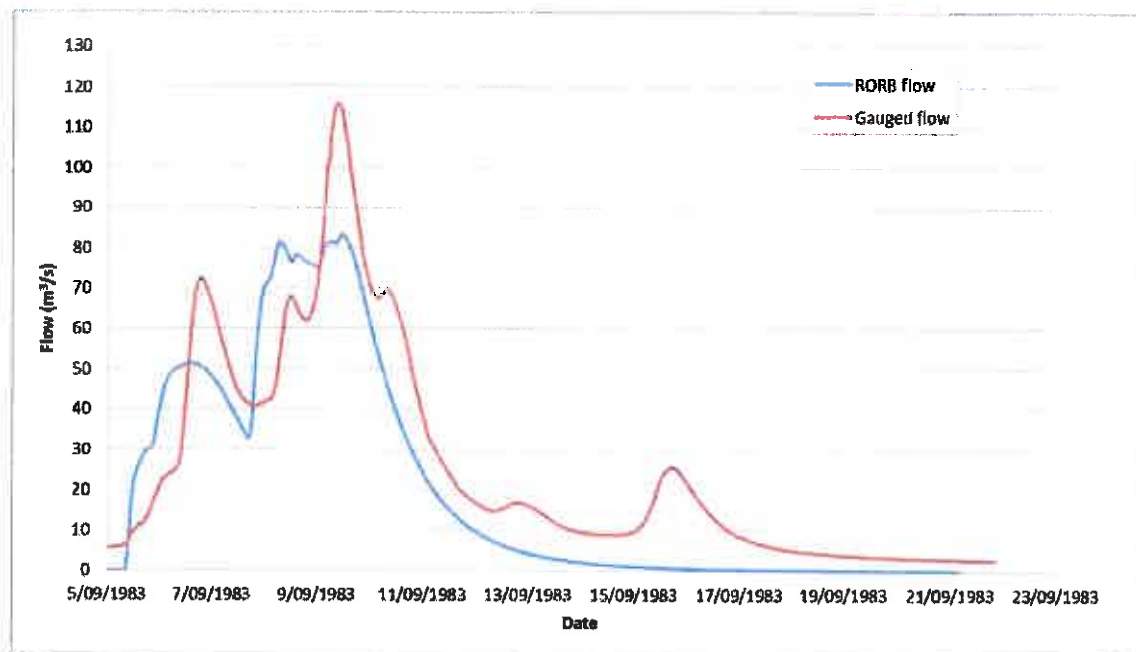
Comparison of the observed and modelled hydrographs for September 1983 and December 2010 are shown in Figure 5-7 and Figure 5-8 respectively. A comparison of peak flow, volume and timing for each event is also shown in Table 5-4.

**Figure 5-7** Glenelg Regional Flood Mapping Project – September 1983 RORB model calibration<sup>1</sup>

The model calibration completed during the Glenelg Regional Flood Mapping Project<sup>1</sup> showed a reasonable match for peak flow and hydrograph shape for the December 2010 event. The September 1983 event however showed a less accurate fit. The modelled hydrograph is missing a distinct peak in hydrograph. The shape is generally well represented other than this sharp rise and fall. The missing peak may be associated with rainfall occurring in the catchment different to that recorded in the temporal pattern at Rocklands Reservoir. This difference was not considered significant to the outcomes of this study given the RORB model was used for hydrograph shape only.

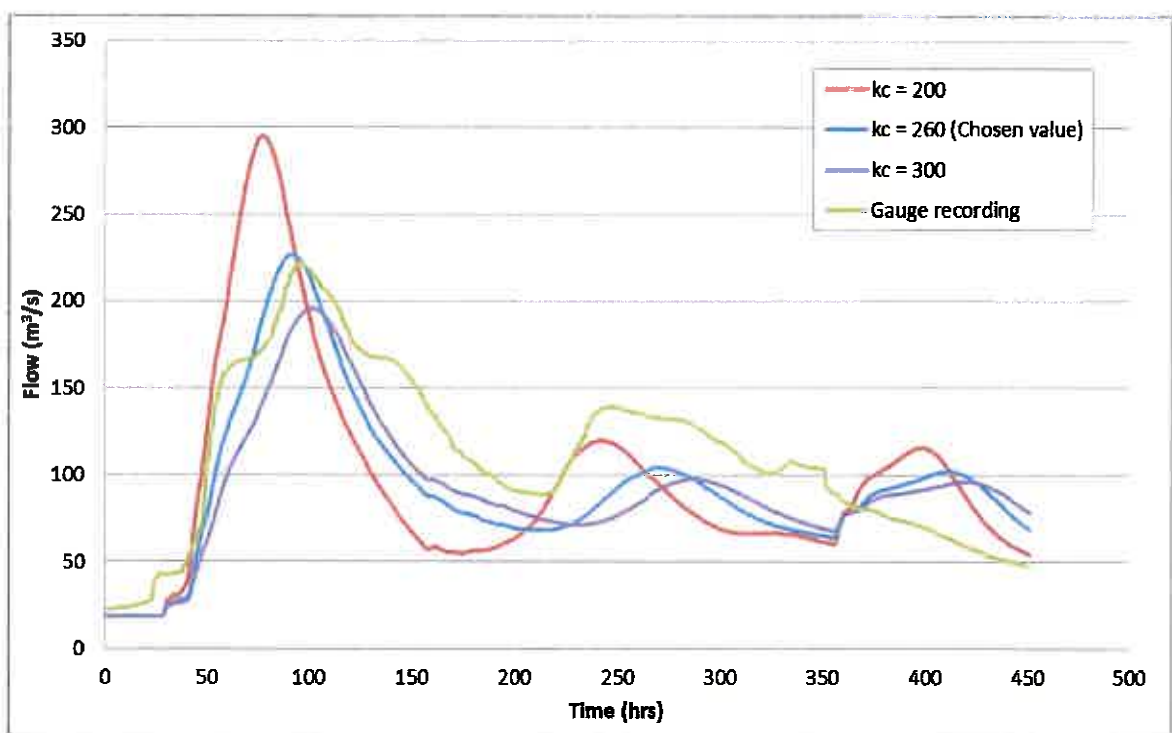
**Figure 5-10** Gauged and modelled hydrographs for 'kc' values of 200, 260 and 300 for the 1983 event at Casterton

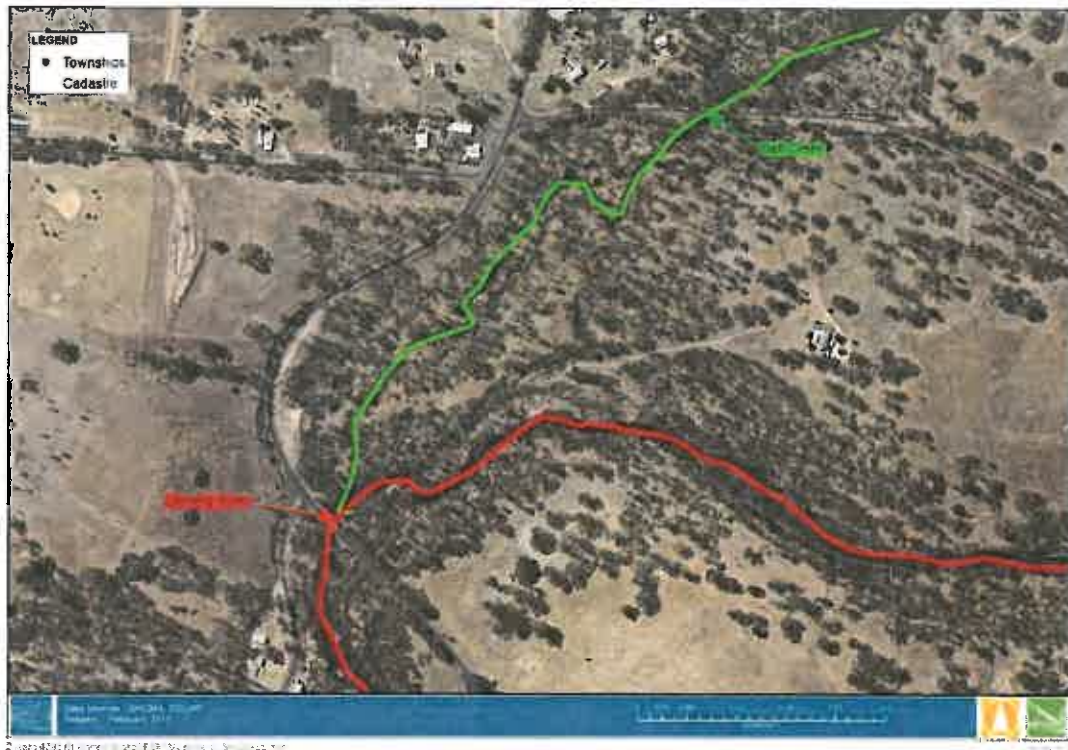
Two bridges were included in the hydraulic model. They were located on the Glenelg River at the Coleraine-Edenhope Road and on Salt Creek at the Harrow-Clear Lake Road. These bridges were modelled as layered flow constrictions as per design plans and site inspections. The modelled structures are shown in Figure 6-3.

**Figure 6-3 Structures included in the hydraulic model**

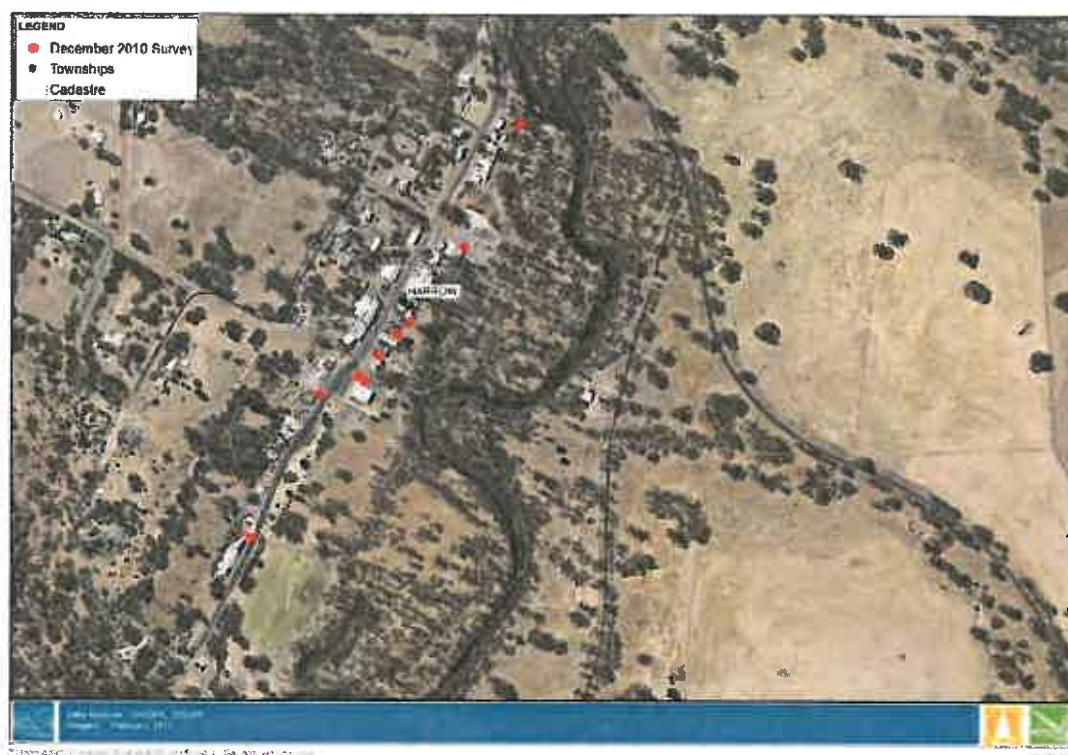
As can be seen from Figure 6-5 below, all the flood marks used for calibration were located in and around the township area.

**Figure 6-5 Locations of December 2010 Surveyed Flood Marks**

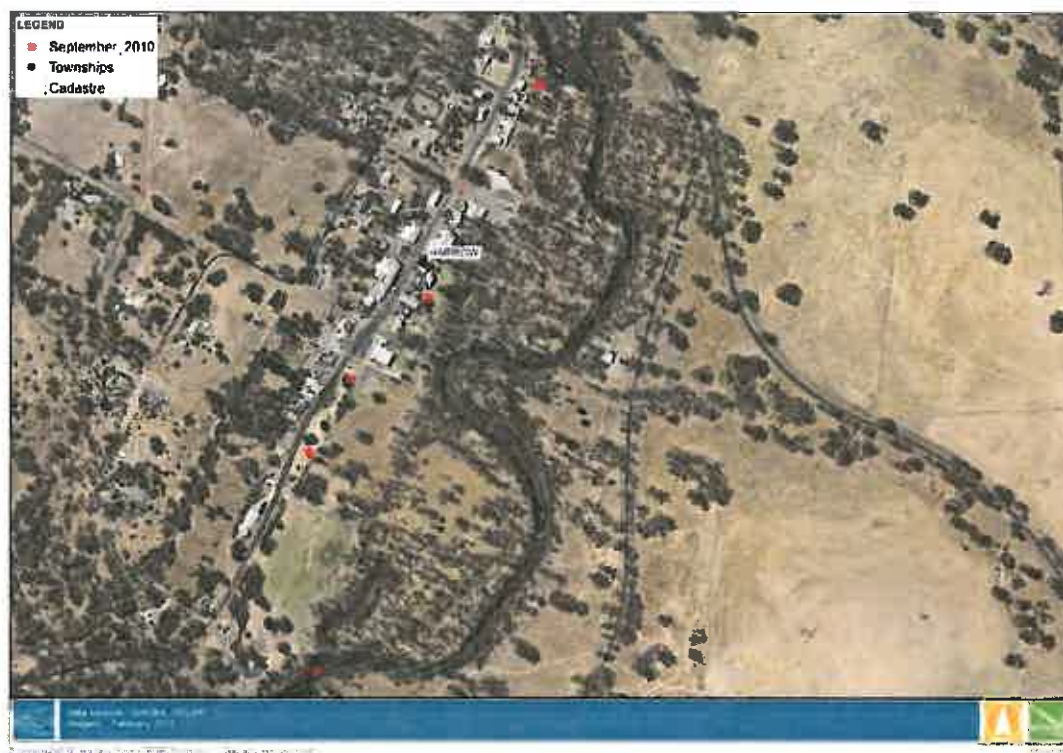
**Figure 6-8** Location of September 2010 surveyed flood marks

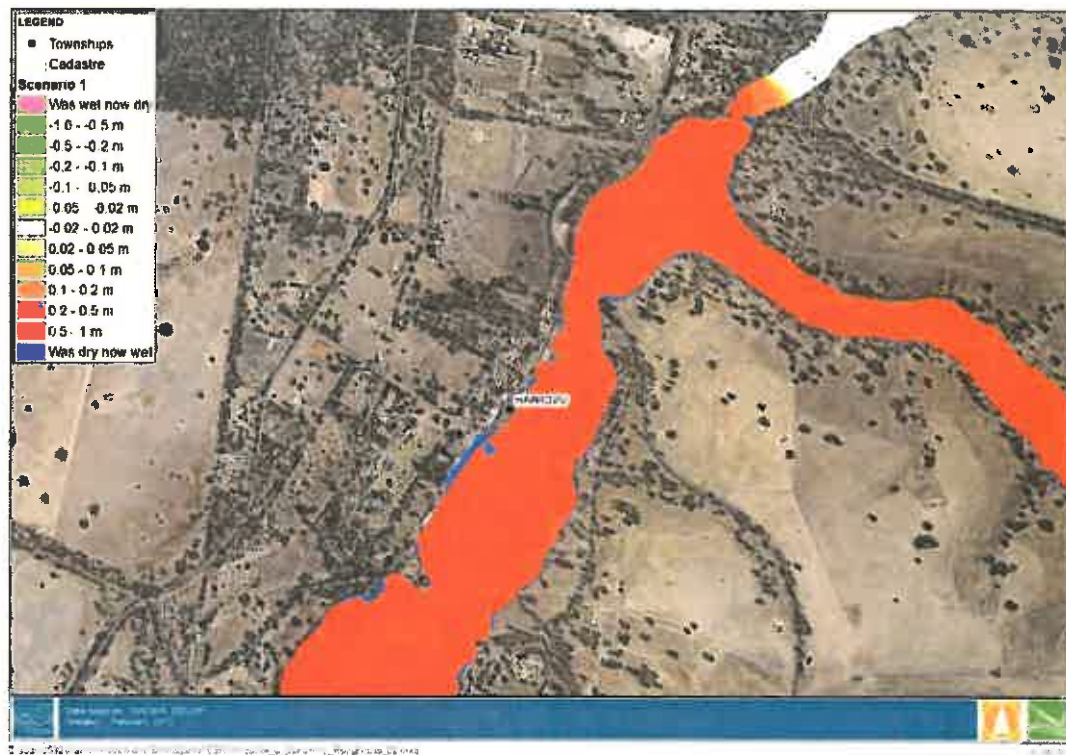
The difference in water levels and extent due to the additional steady state flow of 61.3 m<sup>3</sup>/s (5,300 ML/d) are shown in Figure 7-2.

**Figure 7-2 Difference in water level due to the 61.3 m<sup>3</sup>/s Rocklands release depths at Harrow**

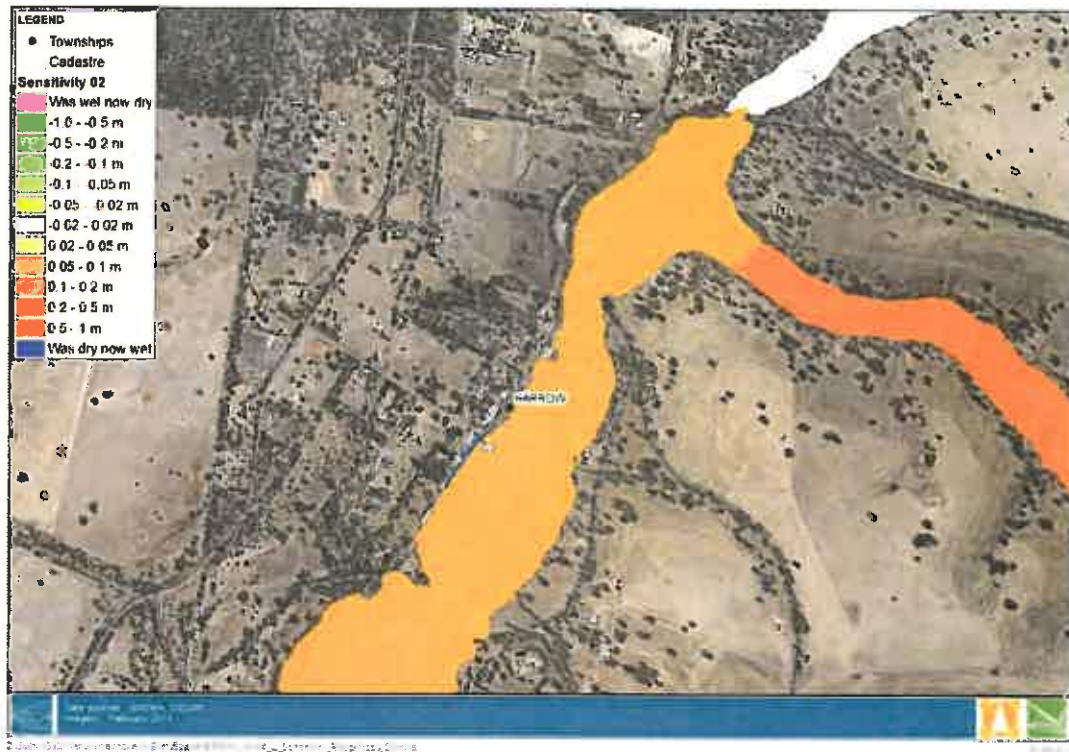
**Figure 7-3** Difference in water level due to the 14.5 m<sup>3</sup>/s Rocklands release - Depths at Harrow

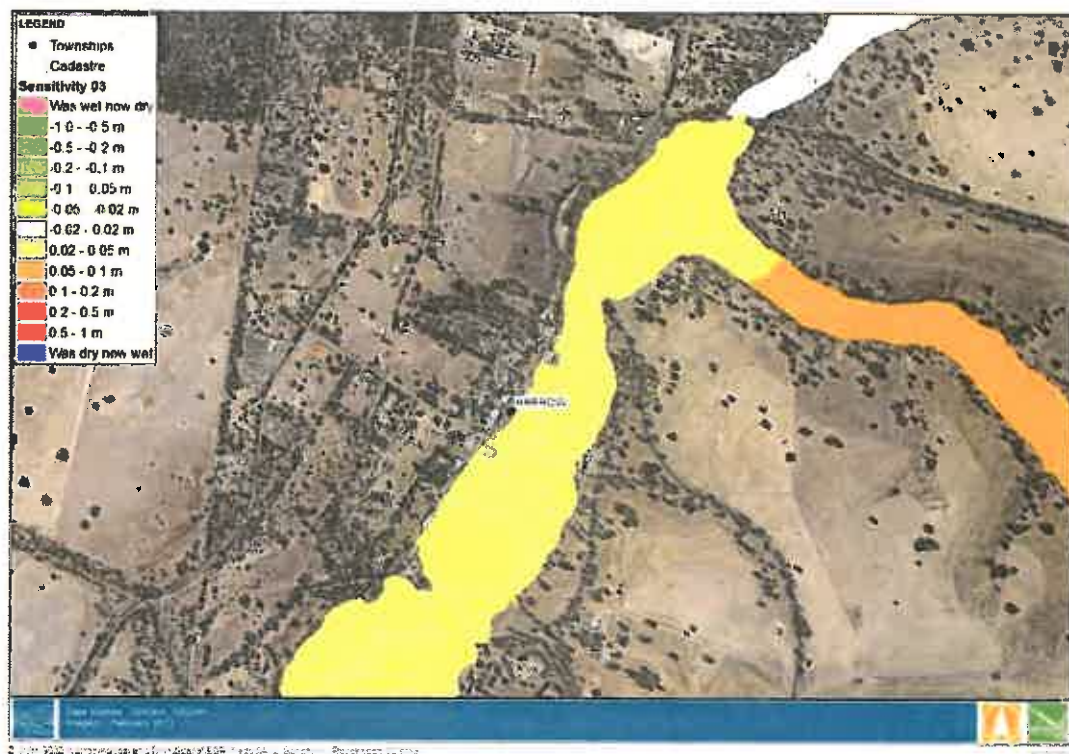
**Figure 7-4** Difference in water level due to the 6.9 m<sup>3</sup>/s Rocklands release - Depths at Harrow

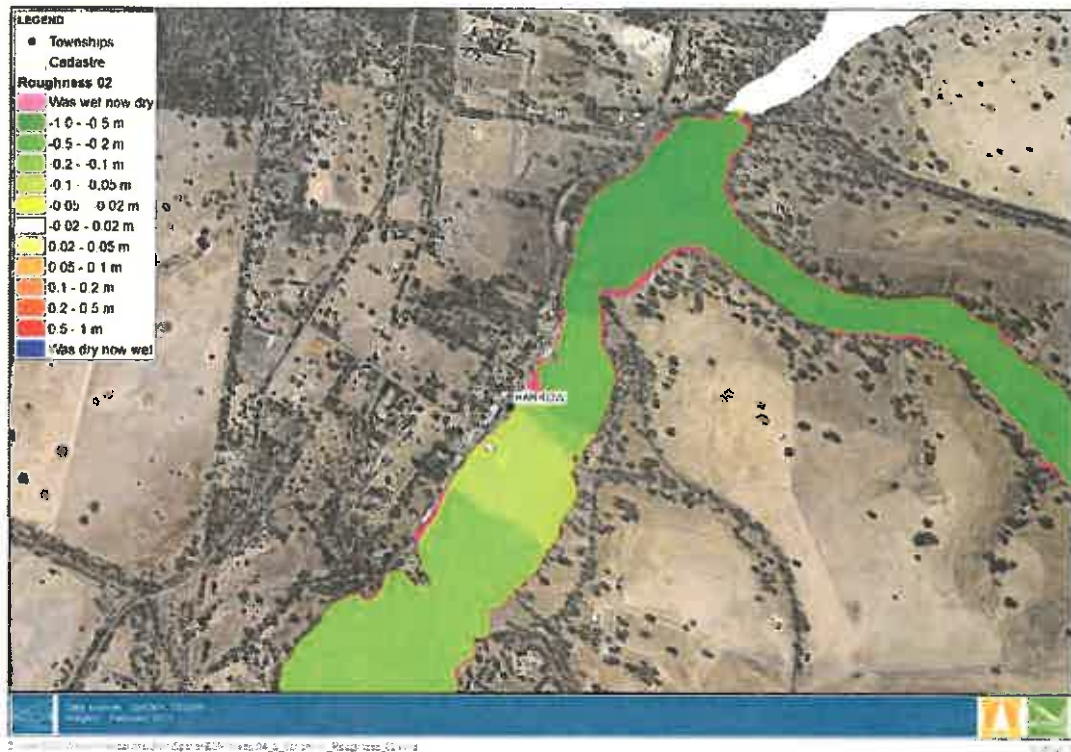
**Figure 7-5** Change in water levels and extents due to an unrealistically decreased floodplain roughness

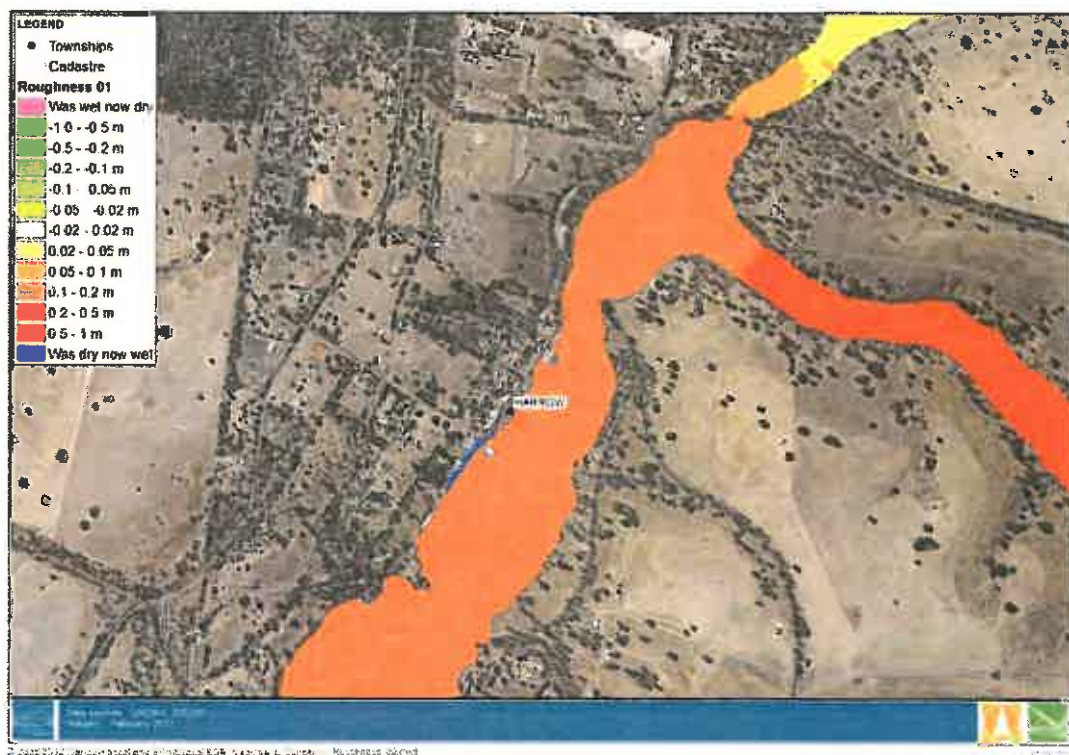
**Figure 7-6** Change in water levels and extents due to a 10% increase to all roughness values

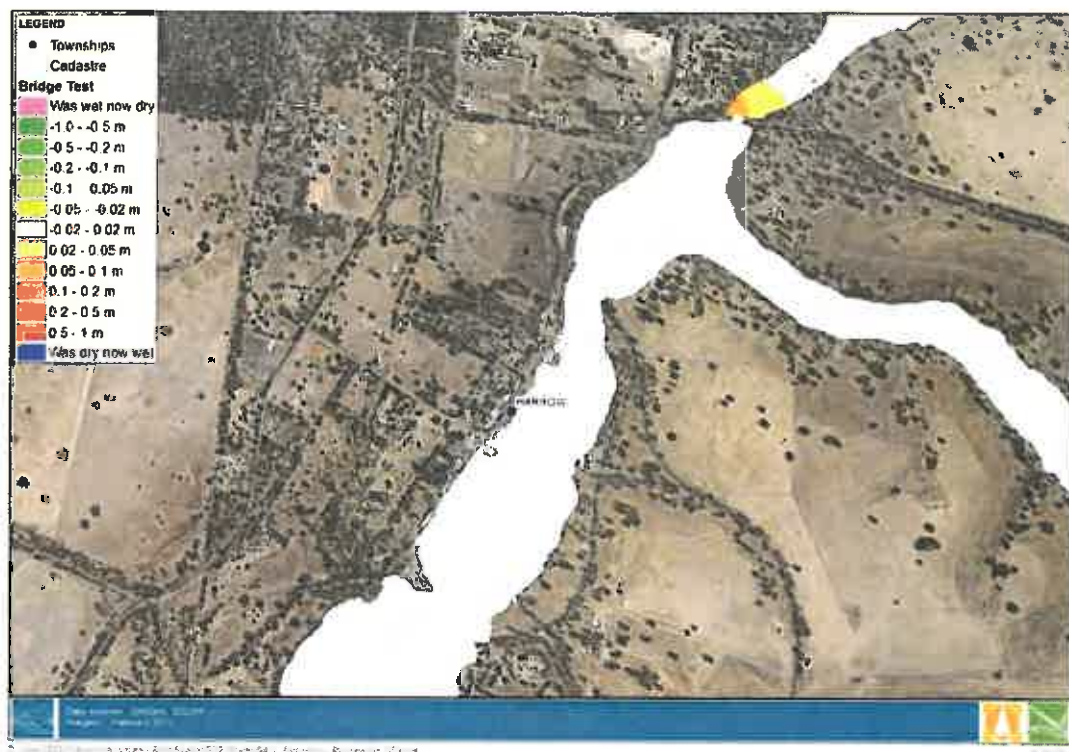
**Figure 7-7 Change in water level due to a 10% blockage of the Coleraine Edenhope Road**

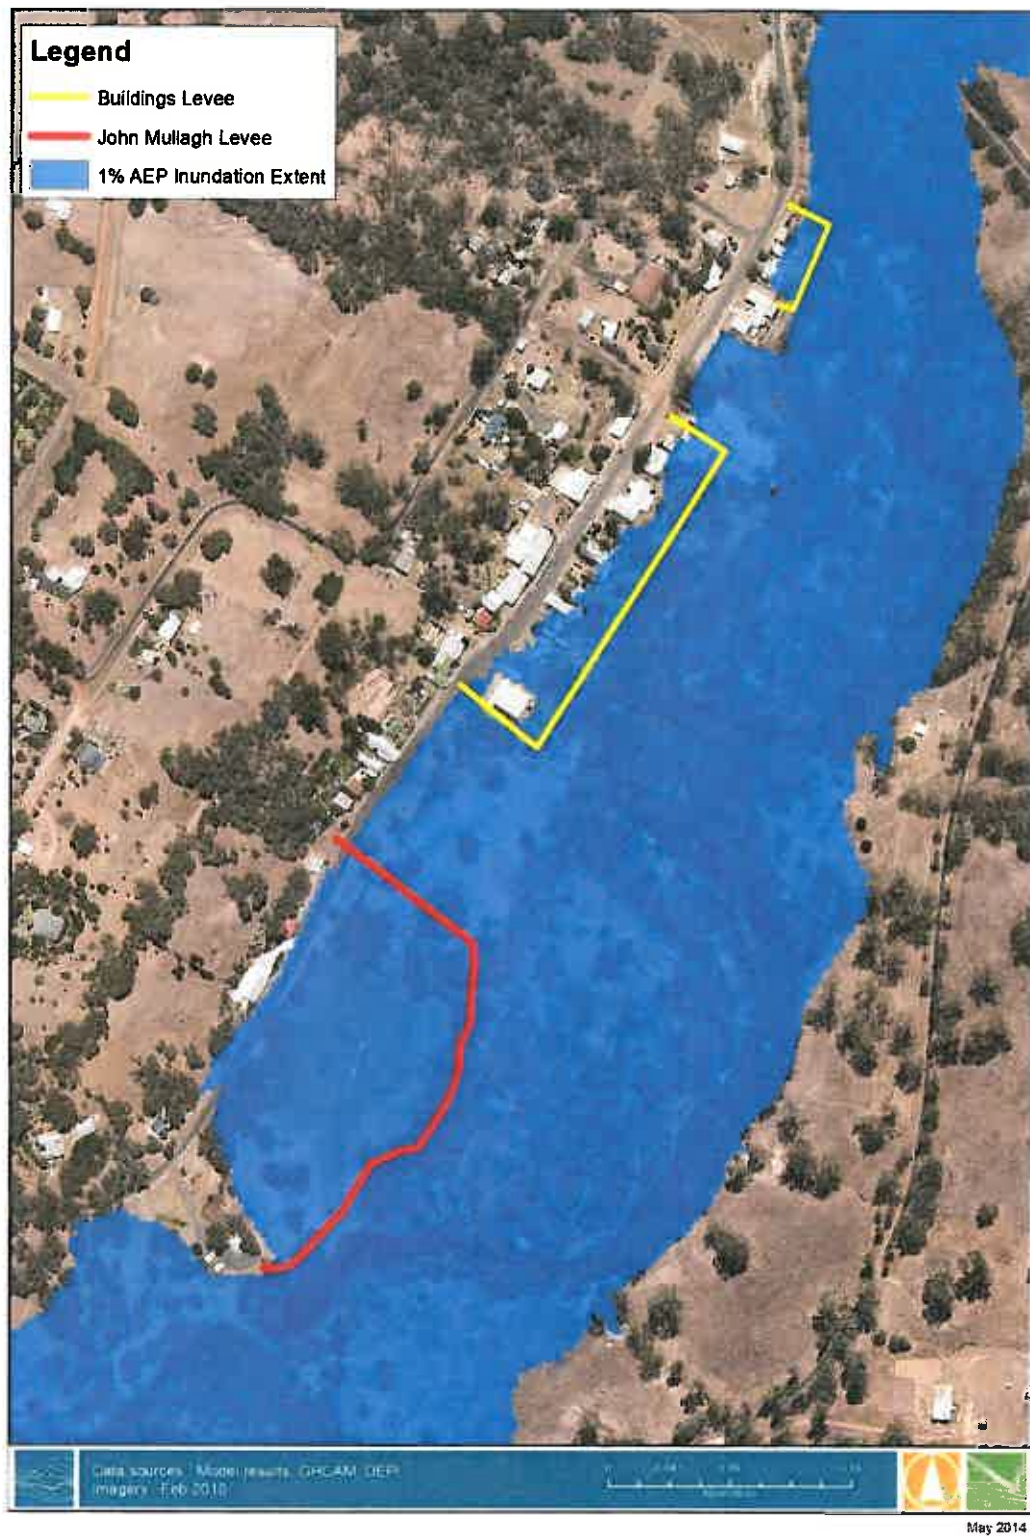
**Figure 8-4** Assessed levee alignments in Harrow

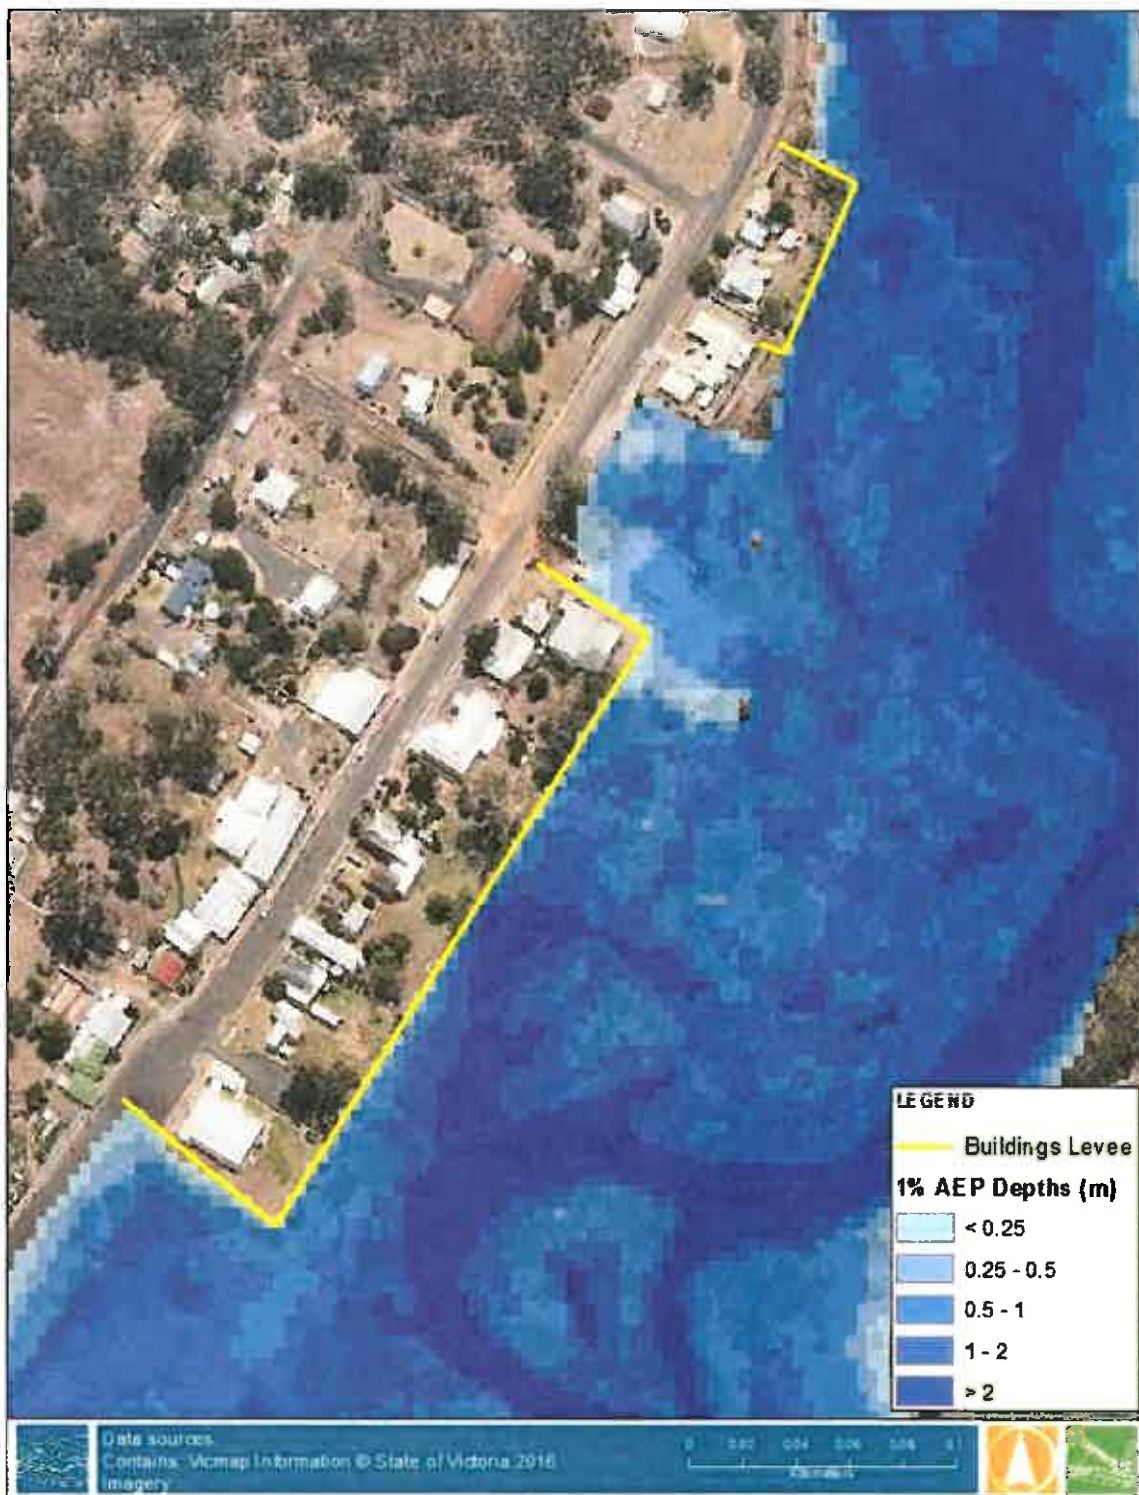
**Figure 8-5 Buildings Levee Alignment and 1% AEP depths**
