Arboricultural Assessment & Report  
*Corymbia ficifolia* (Flowering Gum)  
Wimmera Hwy, Apsley Victoria

## Arboricultural Assessment Report

Wimmera Highway, Apsley

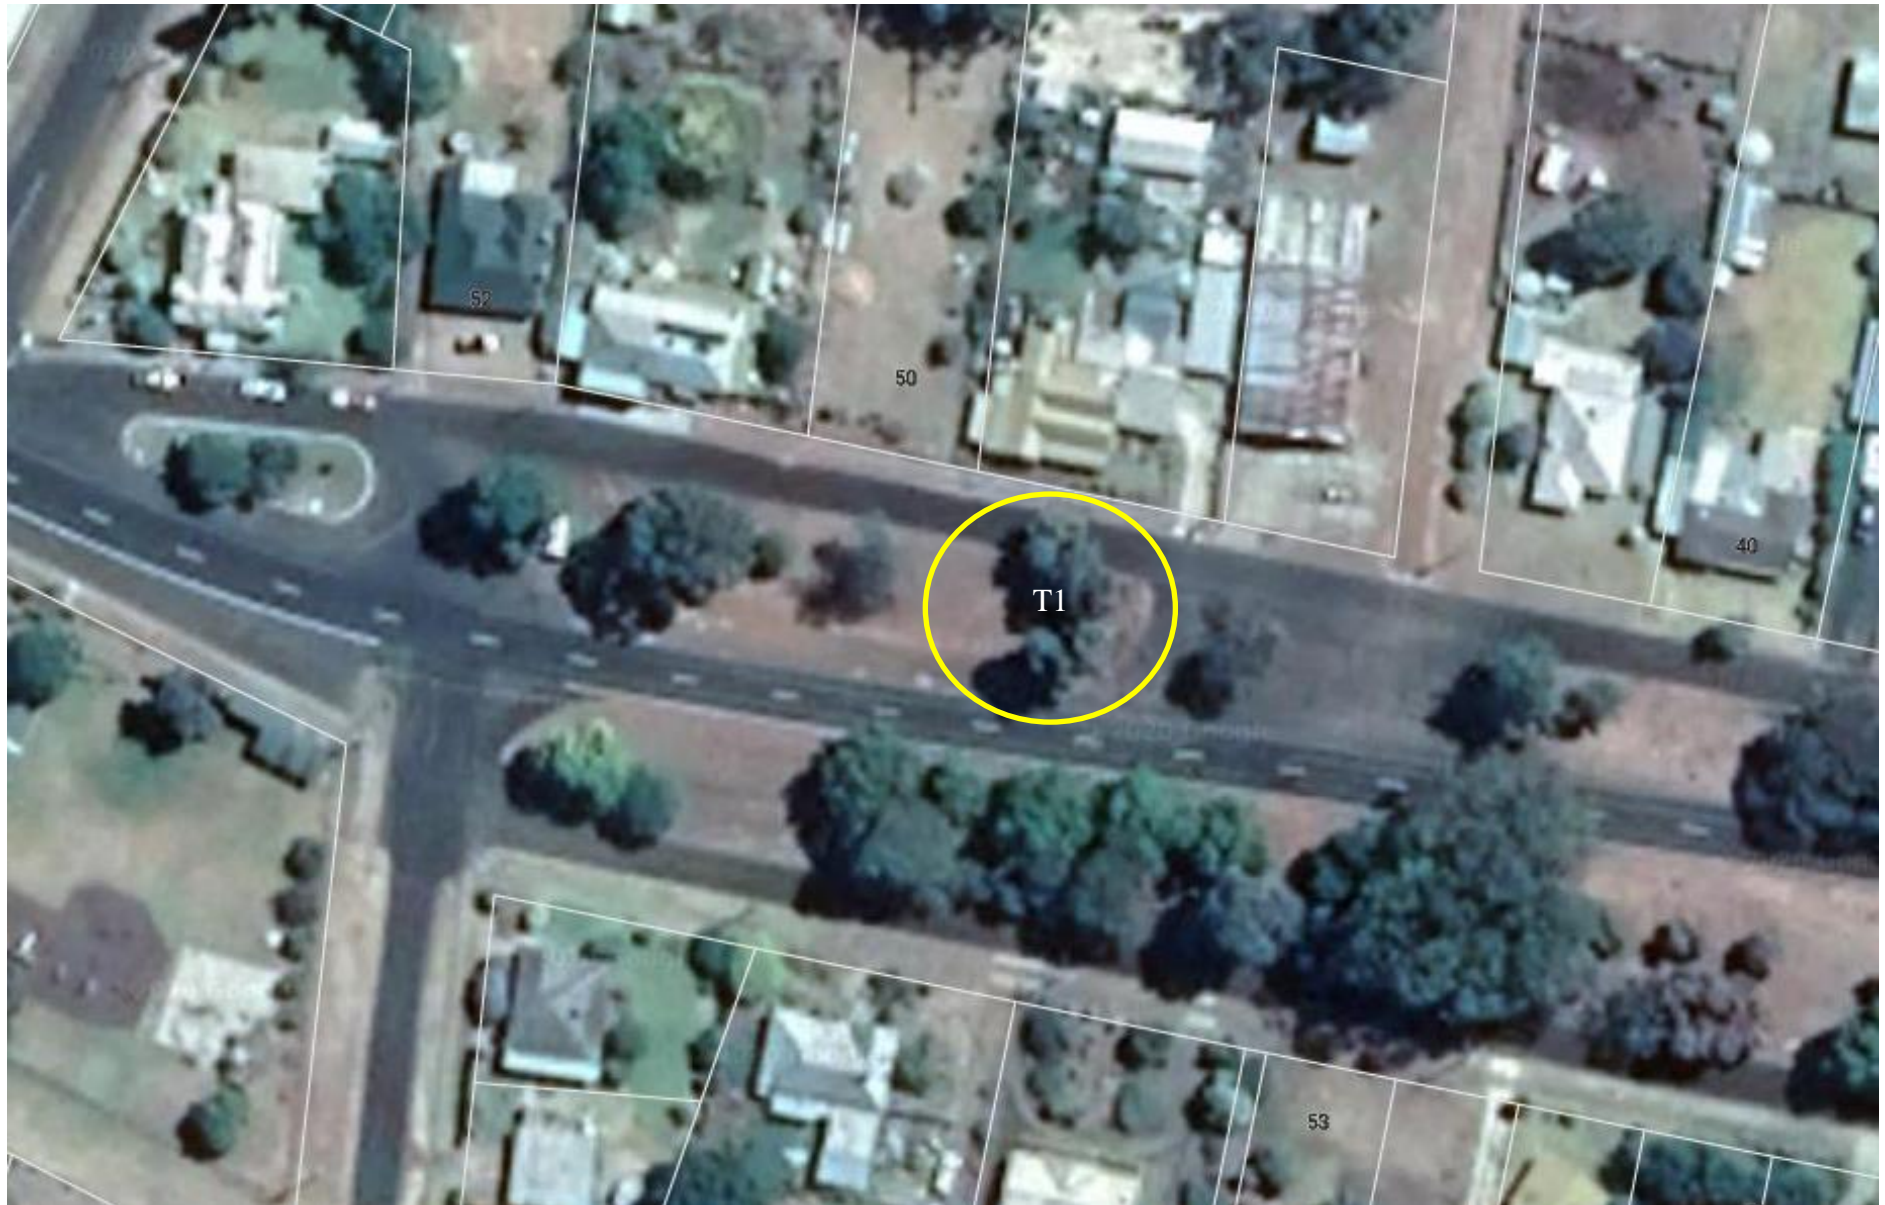
7. PROPOSED WORKS

The tree has recently had a large limb on the northern side fail with areas of dieback in the upper canopy. The majority of the trees foliage is weighted to the south with significant decay in the main stem.

It is consider that the tree no longer meets the requirements for inclusion as a significant tree due to its compromised structure and recent failures with removal and replacement recommended.

- a) The *Corymbia ficifolia* (flowering gum) is recommend for a wide range of pruning methods as below.
- b) Pruning and weight reductions of large heavy outer limbs to reduce the possibility of limb failure.
- c) Removal of deadwood for public safety as this tree is a town icon and has public within close proximity.
- d) Removal of limb touching and protruding onto the powerlines as this could possibly catch on fire.
- e) Crown reduction for general trees health and wellbeing.
- f) Uplift and reducing outer limbs to remove of limbs intruding onto the road.
